A quick, aesthetic restoration of a posterior tooth

Monik Vasant presents a composite posterior restoration case

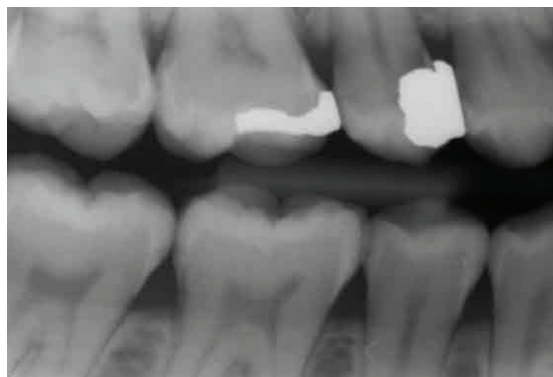
Figure 1: A routine X-ray revealed caries under the amalgam filling in the UR5

A new patient in her early thirties attended for a check up. A routine radiograph revealed caries under the amalgam filling on the UR5. When advised that the tooth needed treatment, the patient revealed she had been unhappy with how it looked. The filling was very visible and shiny when she smiled. The dark appearance of the tooth made her self-conscious. The patient thought treatment would be long and expensive, so she hadn't bothered to ask.

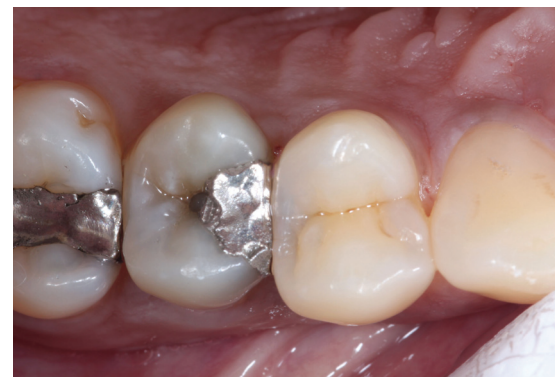
Figure 2: The UR5 filling was very visible when she smiled and the dark appearance made her self-conscious

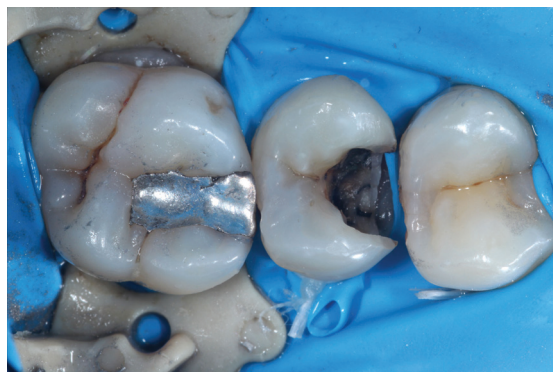
Figure 3: The old amalgam and caries were removed following rubber dam placement

After a local anaesthetic was given, rubber dam (Optidam) was placed, with a clamp on the UR6, exposing the upper right 4, 5 and 6. This was secured in place with floss ties. The old amalgam and caries were removed. The final portion of discoloured dentine was left behind as it was very deep, but the pulp was not exposed and it was still firm.

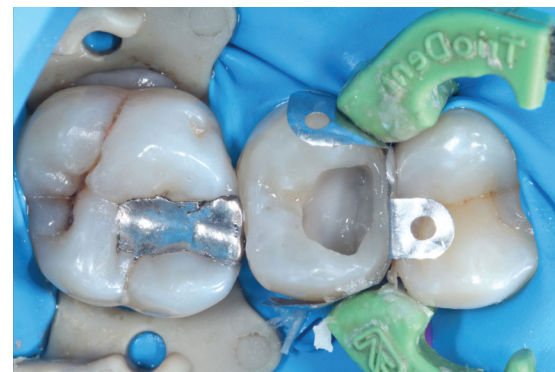
Figure 4: Heraeus Kulzer's Venus Pearl A2 shade was applied to build up the mesial wall

Next, a thin layer of Venus Pearl A2 shade was applied to build up the mesial wall against the matrix. The height was built up to the level of the adjacent marginal ridge. The material was then manipulated with a sharp probe

at a 45° angle. This ensured the edge of the wall was not straight and the natural curved shape of the marginal ridge was maintained. The dentine mass was built up in increments with Venus Pearl ODC shade (opaque dark chromatic).

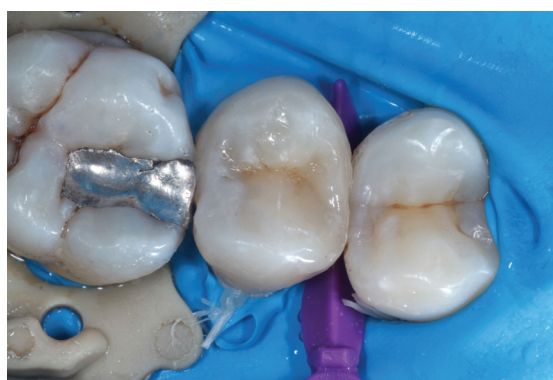
Figure 5: Separation of the masses was achieved by creating fissures down to the dentine layer and then stain was applied

Enamel A2 shade was placed over the occlusal surfaces cusp by cusp. Complete separation of the masses was achieved by creating fissures down to the dentine layer, using a sharp probe. Secondary anatomy was manipulated into the unset material before light curing.

A mix of Venus Color, 'corn' and 'choco' stains, was applied to the fissures using a probe, and pressed in with a long bristle brush. The excess was wiped away with a conventional micro-brush and the stain was cured. Highlights were placed on the ridges using Venus

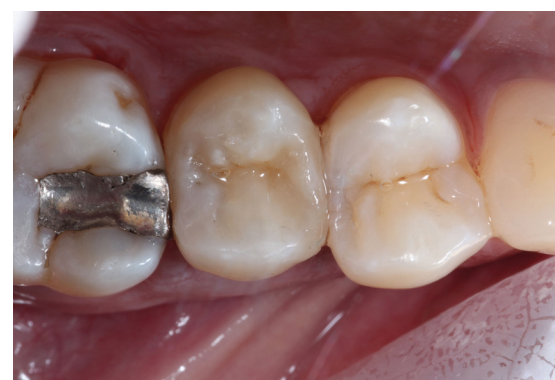
Figure 6: The patient was delighted with the result after having endured an unsightly amalgam filling for years

In this case the clinical outcome was good. The tooth is regularly monitored for vitality and the patient hasn't had any problems with it.

As the caries was so deep, in the long term the tooth may require root canal treatment, but it is currently sound.
